# Assessing Existing Theater Structures and Rigging Infrastructure for Large Production Demands

T. D. Mills, M. G. Paschetto, P.E.<sup>2</sup>, and D. M. Campbell, P.E.<sup>1</sup>

### HOWARD GILMAN OPERA HOUSE AT THE BROOKLYN ACADEMY OF MUSIC

### THE HAMMERSTEIN BALLROOM

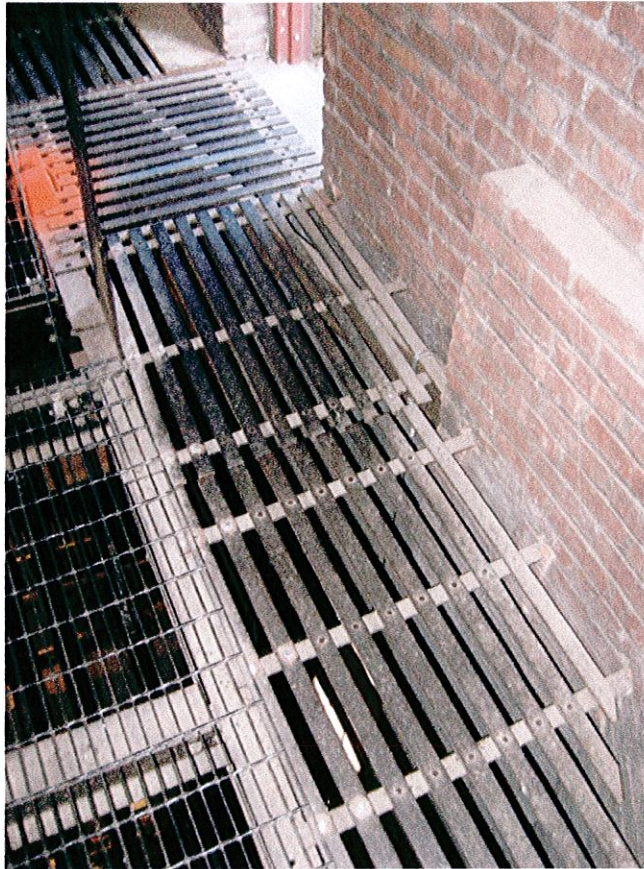
**Figure 5** – Section of Original Slat Walking Surface of Gridiron (note modern bar grating to left)

Based upon on-site inspections, it was found that the gridiron’s original walking surface of 2” x ¼” steel slats had been replaced by modern bar grating sometime in the 1980s. It is easy to understand why the facility replaced the slats; they were bouncy and had ‘dished’ over the years as riggers walked on it. This left the slatted surface across the gridiron wavy with hills over the beams and valleys in between. Evidence was found of the original slats’ attachments along all of the tops of the gridiron support beams. The original attachments consisted of clamping bars that grabbed both edges of the top flanges of the beams of the gridiron support structure. A small area containing some of the original slats as can be seen in figure 5.

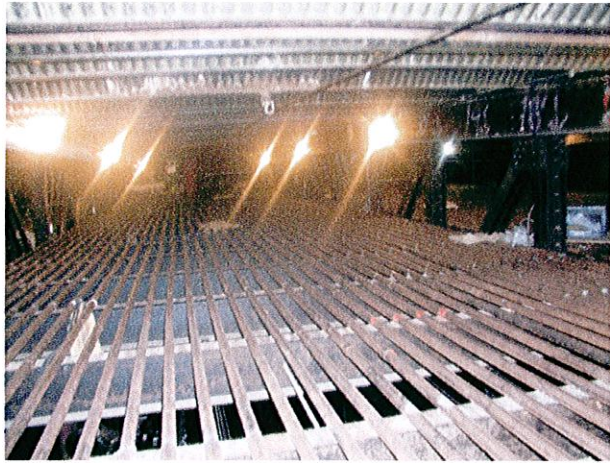
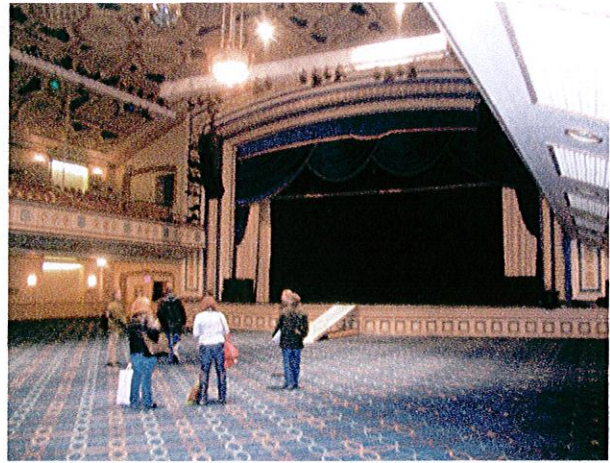
**Figure 8** – Renovated Hammerstein Stagehouse with Added Stage Structure

Built around 1906, the Hammerstein Ballroom may be the oldest theater in New York City. Sometime in the 1970s, major renovations of the Ballroom were undertaken. The renovation included the construction of an addition to the original Hammerstein Ballroom structure. This newer structure is called the Grand Ballroom. The Grand Ballroom's stage was built on top of the Hammerstein Ballroom's original stagehouse roof. See Figure 8.

(a) Hammerstein Gridiron and Original Stagehouse Roof

(b) Grand Ballroom Stage Added to Hammerstein Stagehouse Roof

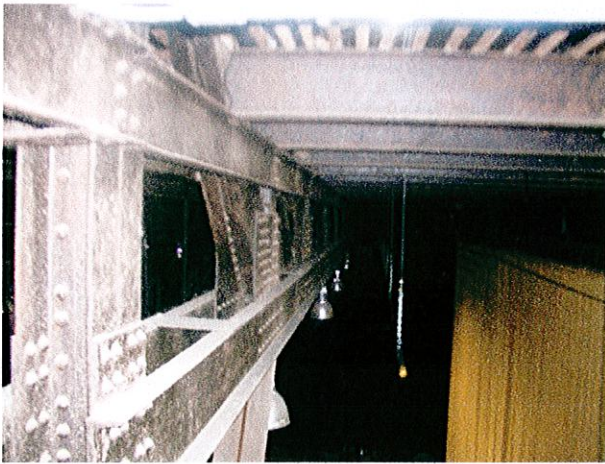
**Figure 9** – Hammerstein Stagehouse Gridiron and Grand Ballroom Support Structure

Three Hammerstein stagehouse trusses help support the Grand Ballroom's stage. The fly house trusses are supported by deep plate girders at the stagehouse's left and right walls. See Figure 9.

(a) A Hammerstein Stagehouse Truss

(b) Hammerstein Plate Girders

The original fly system had loft blocks attached to the stagehouse roof but this fly system was removed so there was a reduction of rigging loads on the stagehouse roof. While the Hammerstein stagehouse trusses were originally designed to carry gridiron and roof loads that include snow and wind, the addition of the Grand Ballroom stage has caused a net increase in the loads the trusses must support despite the removal of the snow, wind, and fly system loads. The engineering evaluation was to determine by how much the added loads from the Grand Ballroom stage reduced the capacity of the fly house trusses and how that impacted the rigging capacity of these trusses for shows in the Hammerstein Ballroom.

Initial findings indicated that the stagehouse trusses' top chords were at 110% of capacity per allowable AISC code stresses when a 100 psf load was applied to the Grand Ballroom stage which directly loads these trusses. This overstress condition precluded additional capacity for handling any rigging over the Hammerstein stage which would be tributary to these same trusses. Essentially, no rigging should occur in the Hammerstein stagehouse if there is any event occurring at the same time in the Grand Ballroom. Indeed, any Hammerstein Ballroom rigging should be evaluated with the stagehouse trusses' limited capacities in mind, whether there was a concurrent event in the Grand Ballroom or not.

Further investigation also found that the plate girders supporting the stagehouse trusses would be over capacity if a 100 psf live load is applied to the Grand Ballroom stage at the same time as rigging loads for the Hammerstein Ballroom. There was no exploration of possible solutions for reinforcing the stagehouse trusses and plate girders.

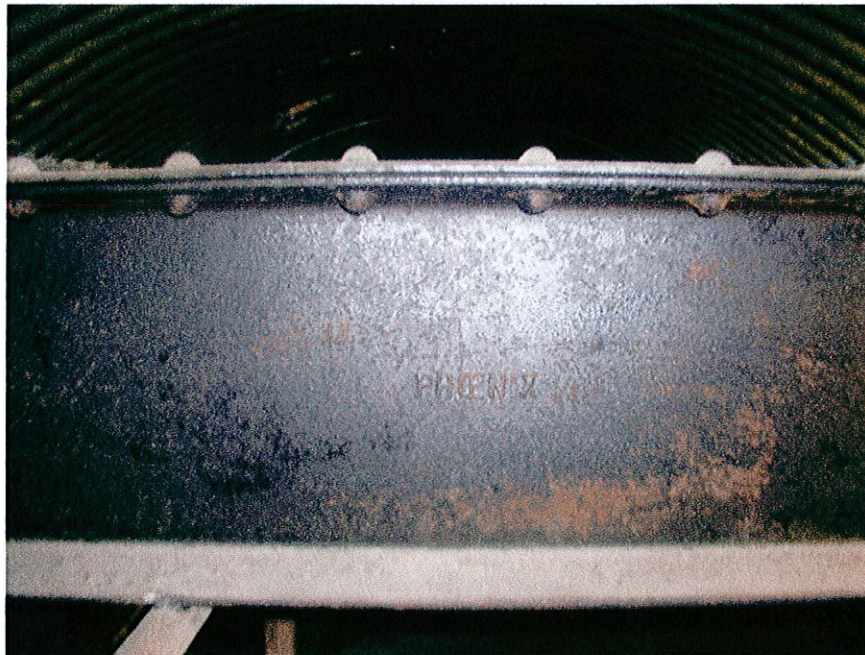
**Figure 10** – Turn of the 20th Century Steel Beam Manufactured by Steel Mill ‘PHOENIX’

Loads applied to the computer analysis models were determined from the site visit notes, knowledge of typical construction material weights, and AISC reference materials pertaining to turn of the 20th century steel construction. Many steel mills at that time had their own steel shapes and identification of sections and materials were made from the manufacturer's markings on beams. See Figure 10.
